## **REFERENCE CONDITIONS**

## WATER

## STREAM CONDITIONS

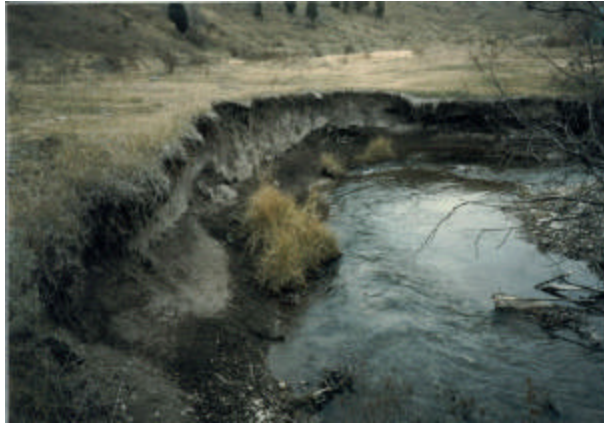
Figure 13: Fall Creek bank erosion, 1986.

In September 1991, Palisades Ranger District Fisheries Biologist Gary Dean performed a stream bank inventory between Echo Canyon and Blacktail on Fall Creek. The survey

identified areas where bank instability was less than its full potential. Approximately 45% of the area surveyed had moderate to heavy cattle impacts.

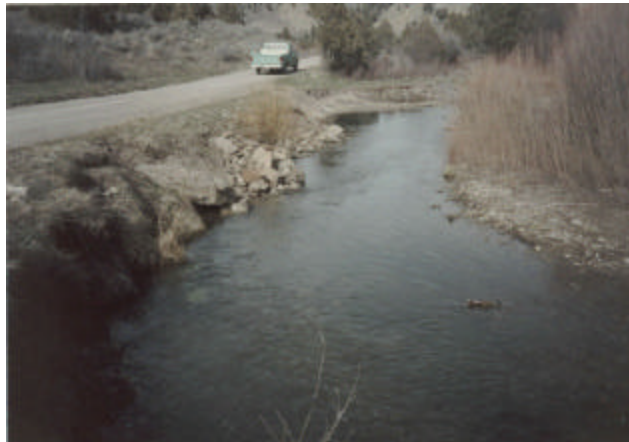
Figure 14: FS Road 077 encroachment upon Fall Creek, Spring 1991.

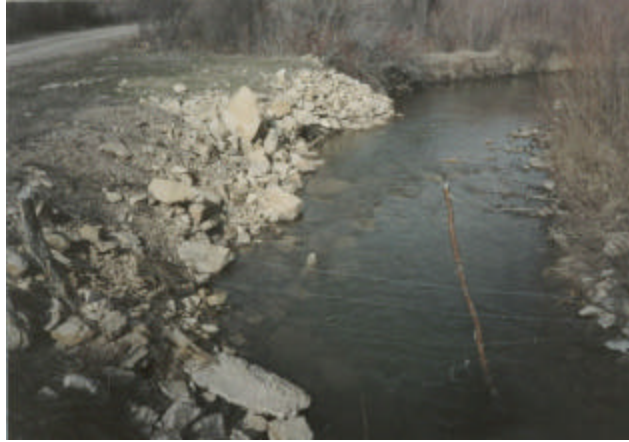
Figure 15: FS Road 077 encroachment upon Fall Creek and riprap, 1991.

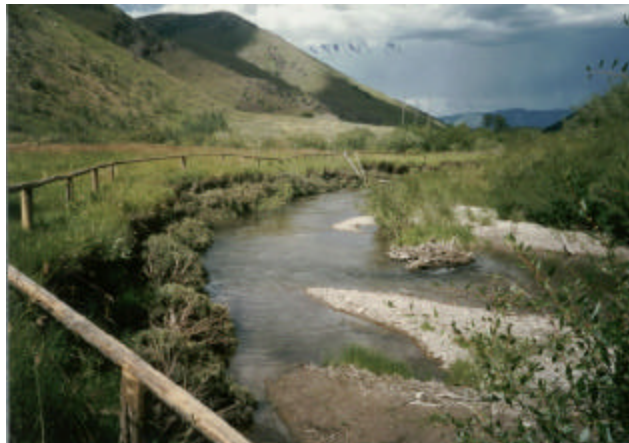
Figure 16: Bank stabilization project, 1993.

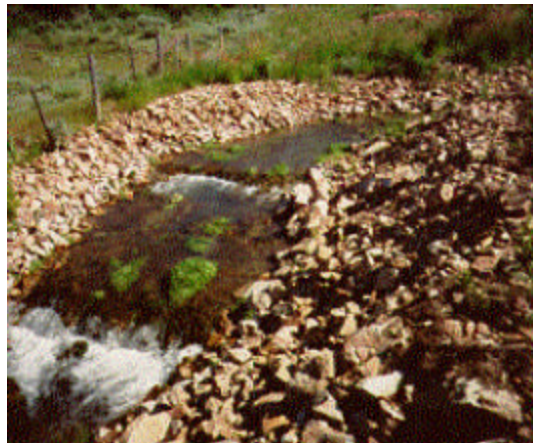
Figure 21: Drop structures placed in Pritchard Creek downstream of old dam site, 1989.

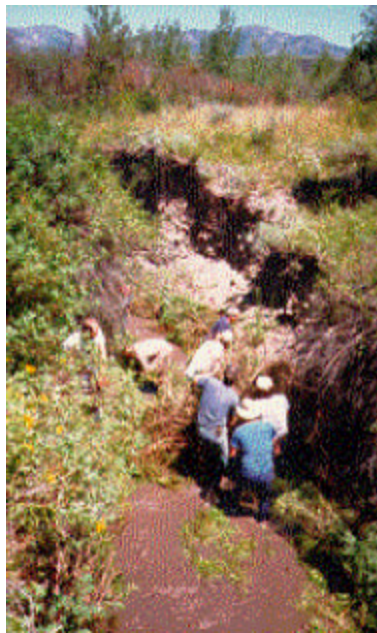
Figure 23: TU volunteers placing tree revetment along bank of Pritchard Creek, August 1987.

In 1987, Palisades Ranger District, in cooperation with Idaho Department of Fish & Game and Trout Unlimited, proposed to rehabilitate the stream channel upstream of the upper fish ladder. The project proposal included the placement of whole trees along the new stream channel within the old reservoir bed and dispersed planting of willows for stream bank stabilization (USDA Forest Service 1987). In 1987, the project was initiated with the placement of 200 trees along a 1/8 mile length of stream by the Forest, IDFG, TU, and Boy Scouts. In 1988, the project was completed when 200 more trees were placed over another 1/8 mile of stream bank.

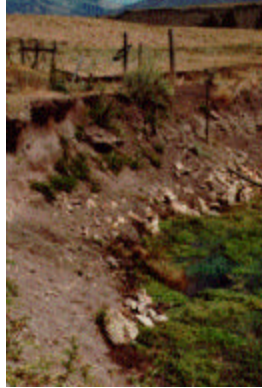
Figure 24: Rip rap trampled by cattle on BLM land reported, 8/5/88.

During the final phase of project implementation, grazing impacts to the portion of the project on BLM land were noted and expressed by Trout Unlimited and Idaho Department of Fish & Game. Some trampling of stream banks and planted trees were noted. Concerned that cattle grazing would nullify their stream rehabilitation efforts, the local chapter of Trout Unlimited, led at the time by Marv Hoyt, elevated their concerns to the national level of the Forest Service. In August, Forest and District staff reviewed the reported damage and observed 7 of the 200 tree revetments and 50 feet of riprap along the fish ladder were damaged. It was felt the vast majority of the revetment structures continued to stabilize the stream banks. Measures that were taken to improve the situation included improving the riprap, constructing a fence to restrict cattle access to the stream, adding trees to the revetment structures, and converting a diversion ditch to a cattle watering area (USDA Forest Service 1988).

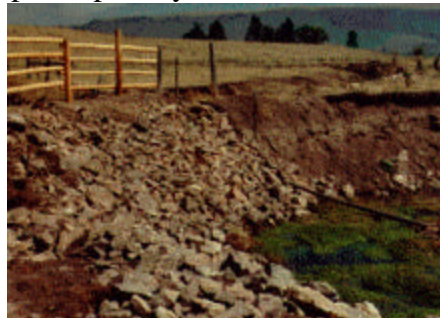
Figure 25: Rip rap trampled by cattle on BLM land fixed by FS, 8/23/88.

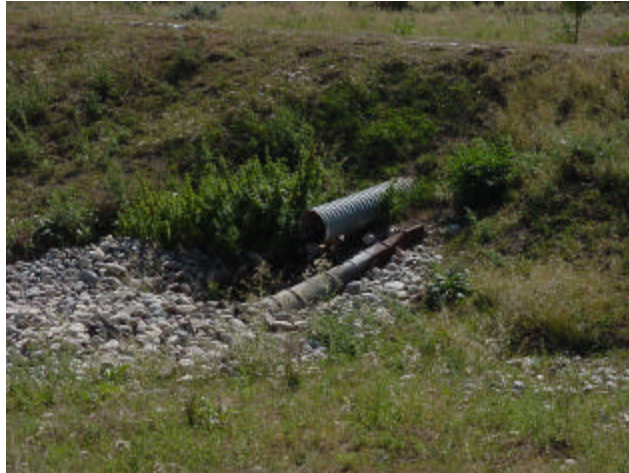
Figure 27: Outlet to private pond in lower Garden Creek was impassable to upstream-migrating fish.

Based on observations on the Conant Valley Ranch in September 2001, the likely route the fluvial fish take to enter Garden Creek is up Granite Creek and up a diversion channel that connects to Granite Creek that, during the spring, carries most of Garden Creek's flow. The diversion channel was excavated many years ago through old river sediment deposits and has significantly downcut through the years to a point it is no longer accessible for irrigation purposes. The ranch has recently excavated a parallel ditch that diverts water from the diversion so they can use it to irrigate their pasture. The operation of their headgates have apparently not affected upstream migrating Yellowstone cutthroat trout.

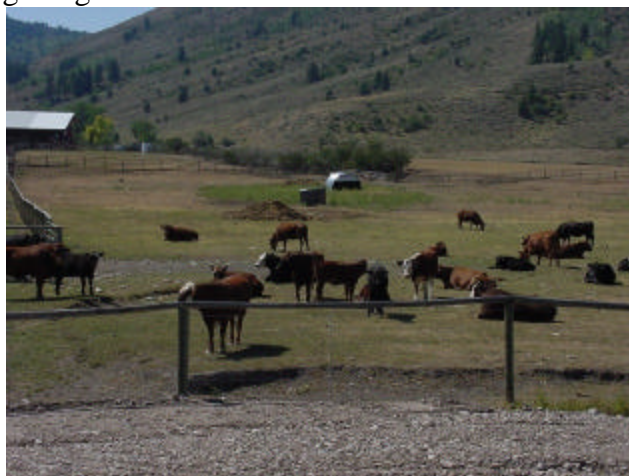
Figure 28: The original channel of lower Garden Creek occurs near the willows located in the center of photograph. Most springtime flow reaching the river flows through an historic irrigation ditch excavated along the toe of the slope in the background of this photo.

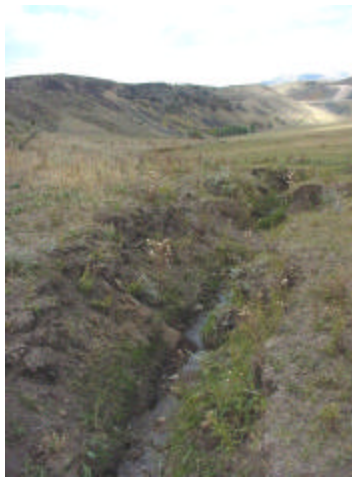
Figure 29: Diversion of Garden Creek, 9/01. This ditchline extends from Garden Creek to Granite Creek and may be the route taken by fluvial fish to access Garden Creek. Note Granite Creek Highway 26 grade in upper right corner.

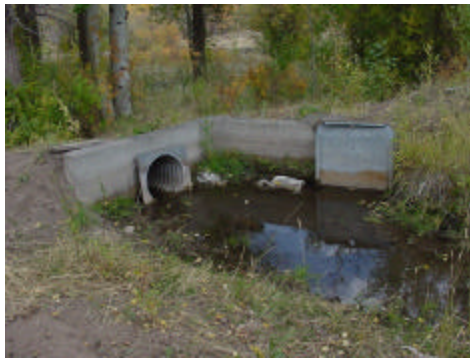
Figure 30: Diversion structure upstream of lower diversion, 9/01.

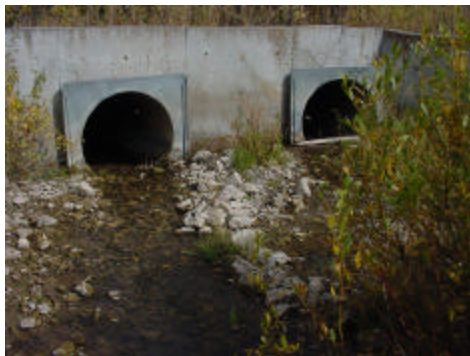
Figure 31: Upper most diversion structure, 9/01.
